APPLICATION OF SURFACE STRAIN GAGES AT THE FAA'S NAPTF

By:
Edward Guo
SRA International, 3120 Fire Road
Egg Harbor Township, 08234, NJ, U.S.A.
Phone: (609) 645-3772 -120
Fax: (609) 645-2881
Edward_guo@SRA.com

PRESENTED FOR THE
2007 FAA WORLDWIDE AIRPORT TECHNOLOGY TRANSFER CONFERENCE
Atlantic City, New Jersey, USA

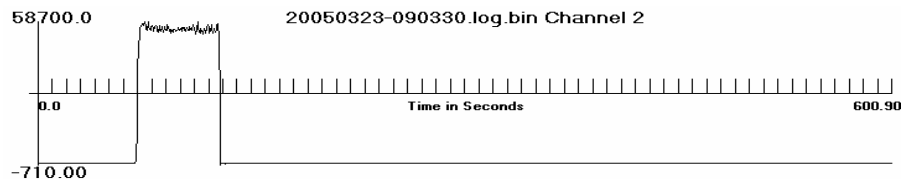
Figure 7. Slow Rolling Load Histories Recorded in Test D2-c. (Six wheels were loaded.)

The test vehicle at the FAA's NAPTF has an on board data acquisition system that records all the vehicle parameters including load magnitude, location and speed. One example of the recorded history of gear location and wheel load magnitudes from the test D-2c is presented in Figure 7. The recorded curve (a) shows the gear was moved from station 145 ft to 224 ft then back to station 145

(a) Gear Location.

(b) Load Magnitudes of the Front Two Wheels.

(c) Load Magnitudes of the Middle Two Wheels.

(d) Load Magnitudes of the Rear Two Wheels

ft in the longitudinal direction, the total distance moved was about 79 ft. The curves in (b), (c) and (d) show the recorded wheel load magnitude histories of the front, middle and rear wheels. The figures indicate that the variation of the wheel load magnitude existed, however, the average of the magnitudes of each wheel load was close to the target value: of 55,000 lbs.

The recorded data in Figure 8 also indicates that two loadings were applied during this data acquisition. The first load application employed six wheels and the second only used two front wheels. Figure 7 and 8 are examples of the corresponding vehicle load information files that are available for every strain gage response. It should be noted that clear analysis of each gage response

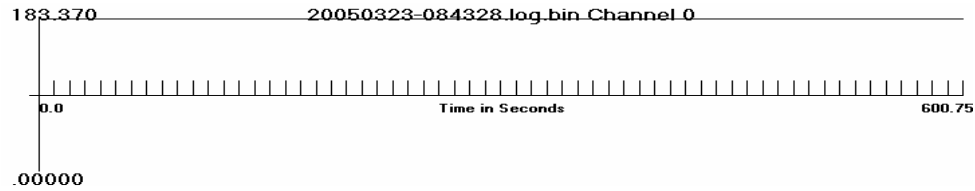
Figure 8. Static Load Histories. (Six wheels were loaded; then two wheels were loaded.)

Figure 8 presents the recorded history of vehicle location and wheel loads in static test S2-c. All records started at 28 seconds after 8:43, March 23, 2005. Figure 8 (a) indicates that the vehicle was stationary during the static test. Figure 8 (b) (c) and (d) indicate that the six wheels were loaded to the target magnitude of 27,500 lbs, then after approximately 10 seconds were increased to 55,000 lbs for another 10 seconds, after which the load was removed from the pavement.

(a) Gear Location.

(b) Load Magnitudes of the Front Two Wheels.

(c) Load Magnitudes of the Middle Two Wheels.

(d) Load Magnitudes of the Rear Two Wheels.
